# Waitohi and Waikawa Streams Characterisation Study

August 2018

### Section 2: A report by the Marlborough District Council that addresses Water Quality in the Waitohi and Waikawa catchments

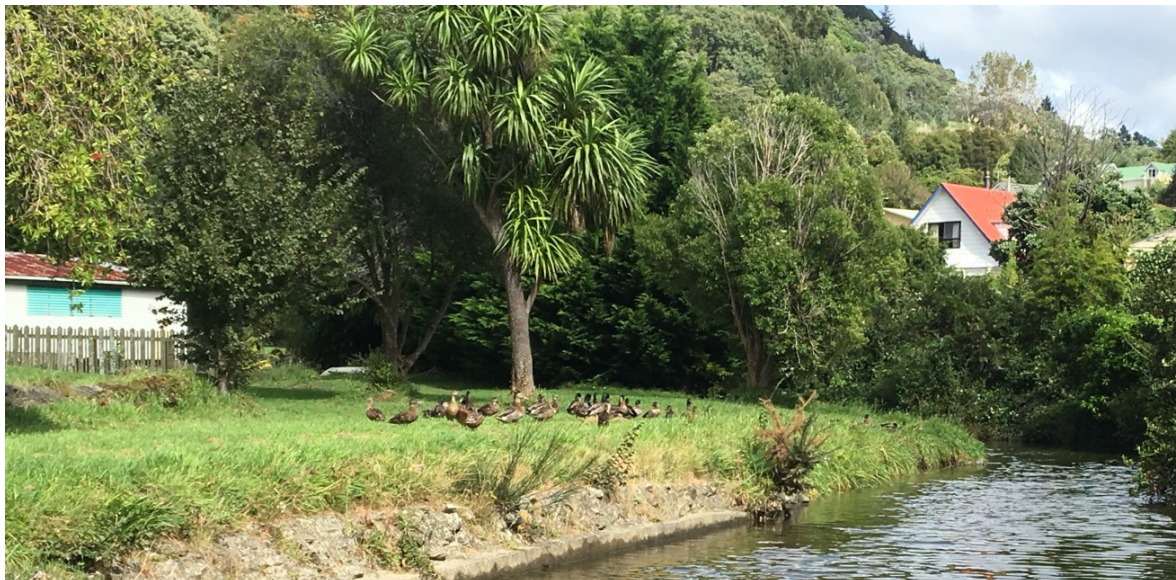
Figure 11: Large number of Mallard Ducks at the Waitohi River at site Wt4.

Mallard ducks, which are the most likely source of faecal contamination (*Figure 11*). The sites located furthest upstream and downstream on Waitohi River had the lowest dry weather *E. coli* concentrations in this catchment.
